**DEPARTMENT OF TRANSPORTATION**

Contract #: 04-0120F4Cty: SF/ALA Rte: 80 PM: 13.2/13.9File #: 69.28**WELDING INSPECTION REPORT****Resident Engineer:** Pursell, Gary**Address:** 333 Burma Road**City:** Oakland, CA 94607**Report No:** WIR-002612**Date Inspected:** 04-May-2008**Project Name:** SAS Superstructure**OSM Arrival Time:** 630**Prime Contractor:** American Bridge/Fluor Enterprises, a JV**OSM Departure Time:** 1530**Contractor:** Zhenhua Port Machinery Company, Ltd (ZPMC), Changxing Island **Location:** Shanghai, China**CWI Name:** See below**CWI Present:** Yes No**Inspected CWI report:** Yes No N/A**Rod Oven in Use:** Yes No N/A**Electrode to specification:** Yes No N/A**Weld Procedures Followed:** Yes No N/A**Qualified Welders:** Yes No N/A**Verified Joint Fit-up:** Yes No N/A**Approved Drawings:** Yes No N/A**Approved WPS:** Yes No N/A**Delayed / Cancelled:** Yes No N/A**Bridge No:** 34-0006**Component:** OBG/Tower**Summary of Items Observed:**

## WELDING INSPECTION REPORT

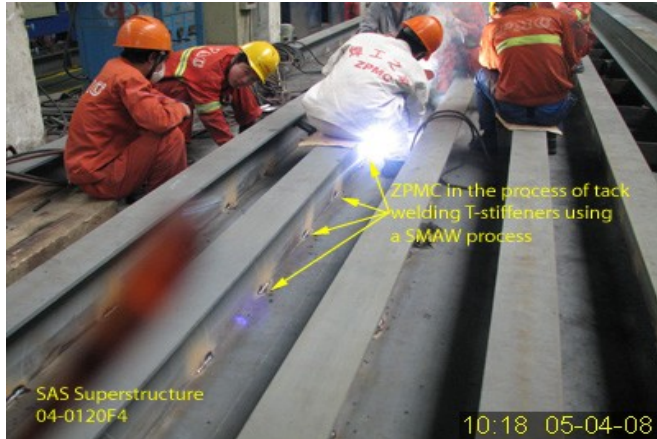
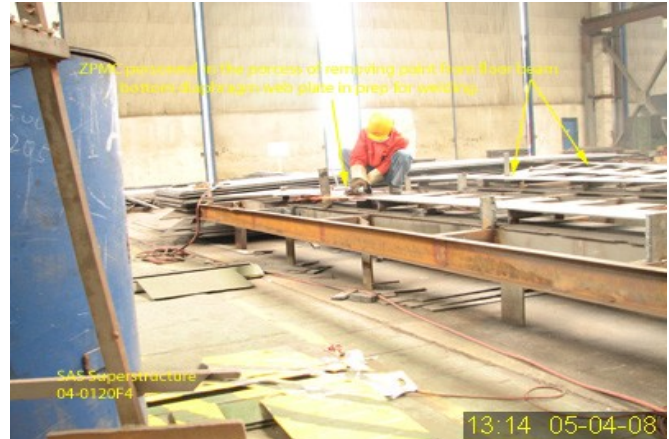
The following digital photograph below illustrates observation of the activities being performed.
